# Demonstration Assessment of Light Emitting Diode (LED) Walkway Lighting

*Host Site: Federal Aviation Administration  
William J. Hughes Technical Center,  
Atlantic City, New Jersey*

**Final Report prepared in support of the  
U.S. DOE Solid State Lighting  
Technology Demonstration Gateway Program**

March 2008

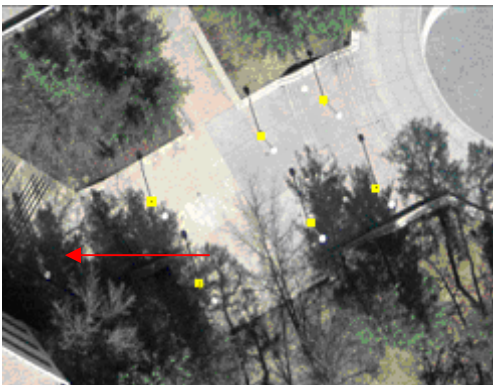
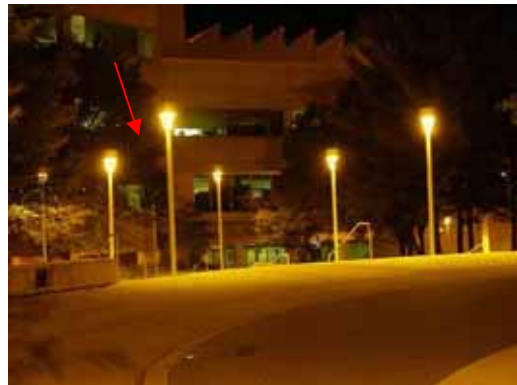
**Figure 2.1.** Aerial and Color Views of Original HPS Luminaires

The chosen area is a high-volume walkway running from Parking Lot B to Building 300; it includes three short sets of stairs with a number of other staircases in the general area. The walkway is also adjacent to another building, Building 316, which serves to further increase the volume of foot traffic past the demonstration luminaires. A total of six luminaires illuminate the walkway. Four of the luminaires (L3, L4, L5, and L6) are located on a flat section of walkway and two luminaires (L1 and L2) are located on a higher section of walkway leading to a round plaza. This section is adjacent to the first section via a staircase of five stairs. All of the luminaires are mounted on 14-foot poles. A seventh fixture is located nearby but was not included in the demonstration. This seventh luminaire is obscured by foliage from an adjacent tree much of the year (see arrows in Figure 1.1). Image 1 was taken from a GIS satellite; yellow dots in the photo indicate the location of the six luminaires in the demonstration. Image 2 was taken at night during the initial site visit.

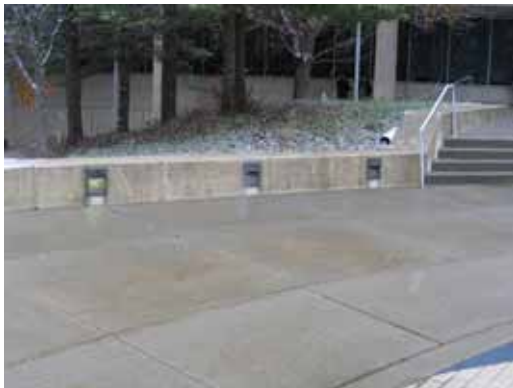
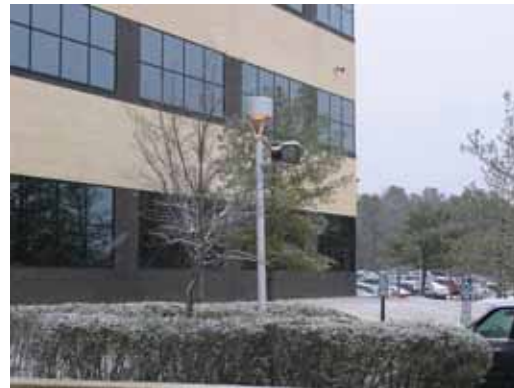
Recessed step lights are also installed within the plaza (see Image 3 in Figure 2.2), which appear to use metal halide (MH) lamps, though they were not working properly at the time of demonstration. The round plaza adjacent to the demo walkway contains similar step lights, and only a few of those were working properly. Floodlights are also mounted to some of the walkway poles just outside of the round plaza (see Image 4 in Figure 2.2). The floodlights use HPS lamps and provide illumination where the step lights do not. Due to the grade changes between the plaza and the demonstration walkway (about

4 feet) the light from the HPS floodlights spills over onto the walkway. Supply voltage to all luminaire types is 277 volts.

**Figure 2.2.** Nearby Walkway Area Lights that Were not Replaced. Image 3 shows Recessed Step Lights, most of which were not working. Image 4 shows flood lights that were mounted to nearby poles to provide stair lighting in place of the non-functioning recessed step lights; these flood lights provided some light to the test area which was included in the ambient light measurements.

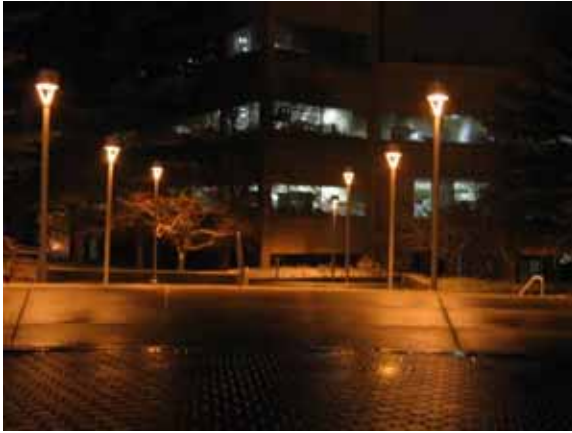
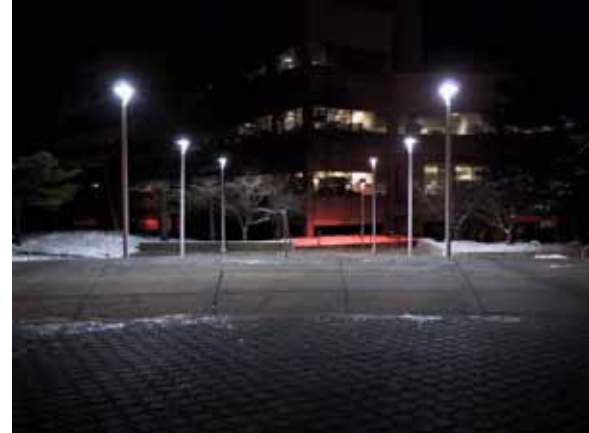
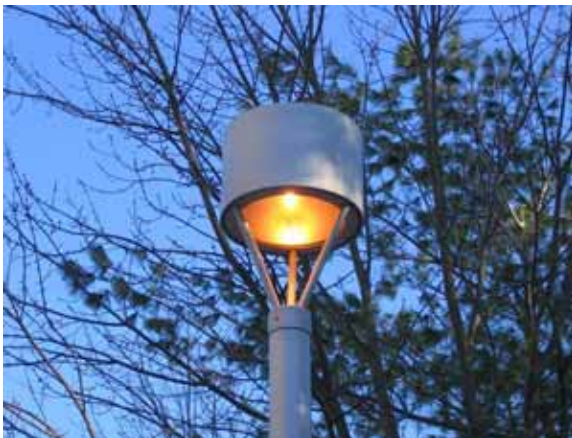
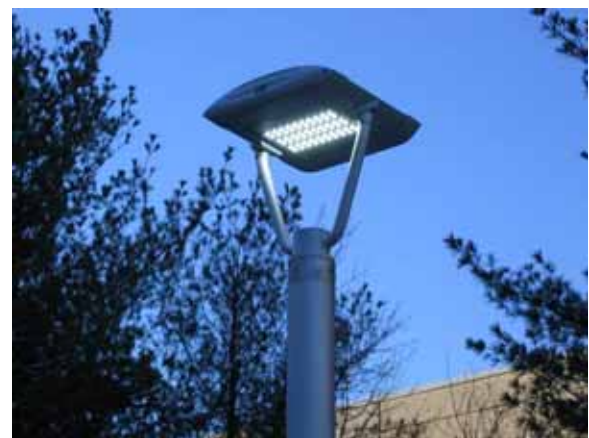
Figure 2.3 provides comparative side-by-side images of the two luminaire types. Image 5 and Image 7 in Figure 2.3 are of the original HPS luminaires and Image 6 and Image 8 are the replacement LED luminaires. One of the original HPS fixtures is also visible in the background of Image 6.

**Figure 2.3.** Images 5 and 6 show the Six Study Luminaires with the original HPS Lighting and After Replacement with the LED Luminaires. Images 7 and 8 show details of the HPS and LED Luminaires.

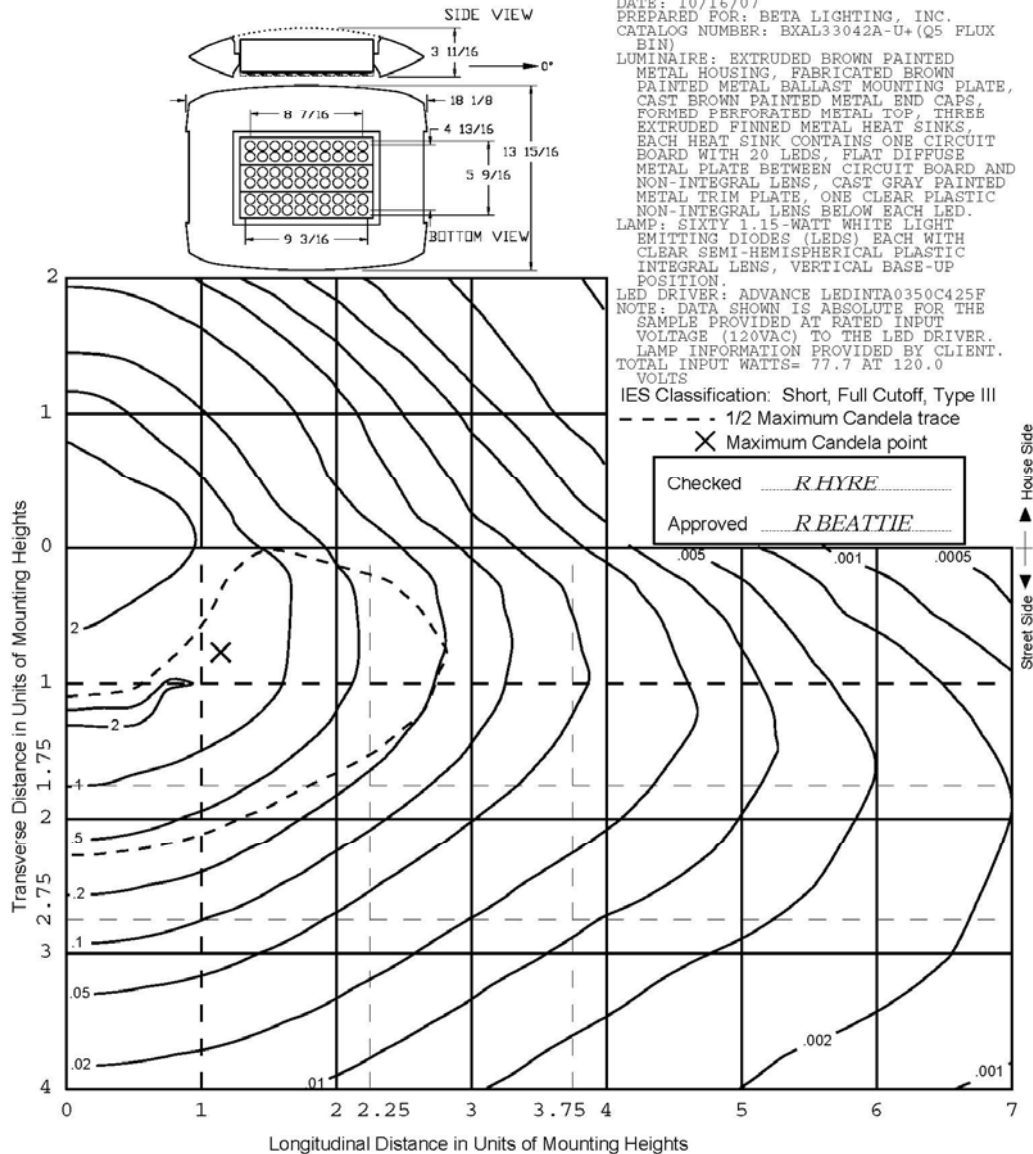
## ISOFOOTCANDLE LINES OF HORIZONTAL ILLUMINATION Values based on 15 foot mounting height.

<sup>1</sup> This tested unit was designed for a different application but is the same as the luminaires used at FAA other than the pattern distribution, i.e., this tested unit has Type III rather than Type V distribution. Luminaire design, lumen output, power consumption, and efficacy are otherwise similar.

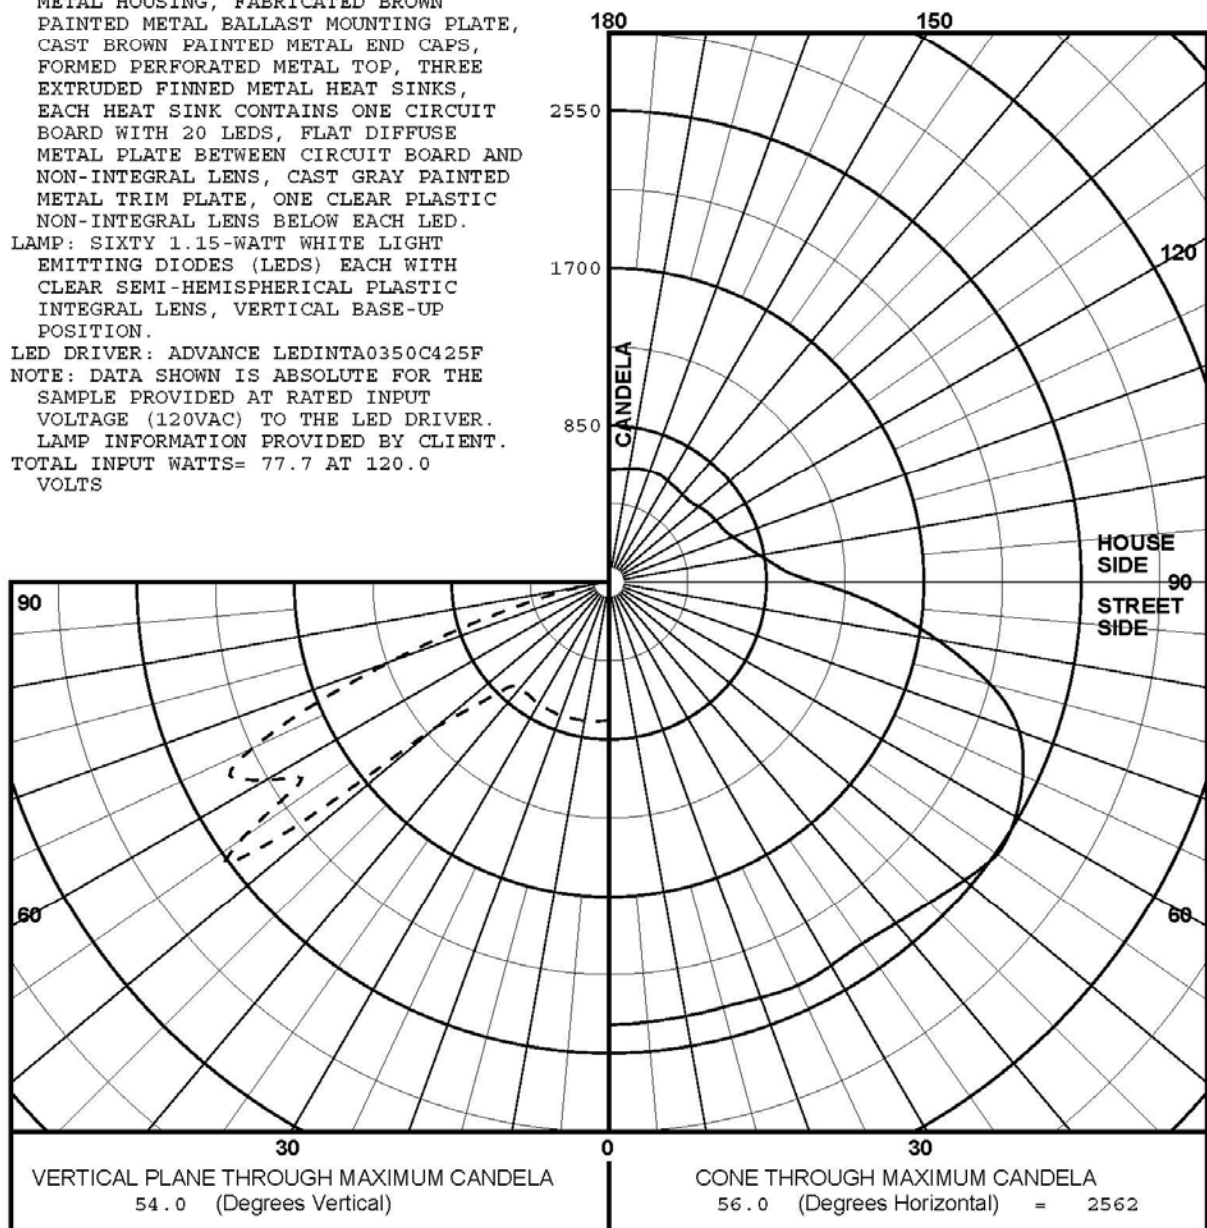
TOTAL INPUT WATTS= 77.7 AT 120.0  
VOLTS

MAXIMUM PLANE AND MAXIMUM CONE PLOTS OF CANDELA

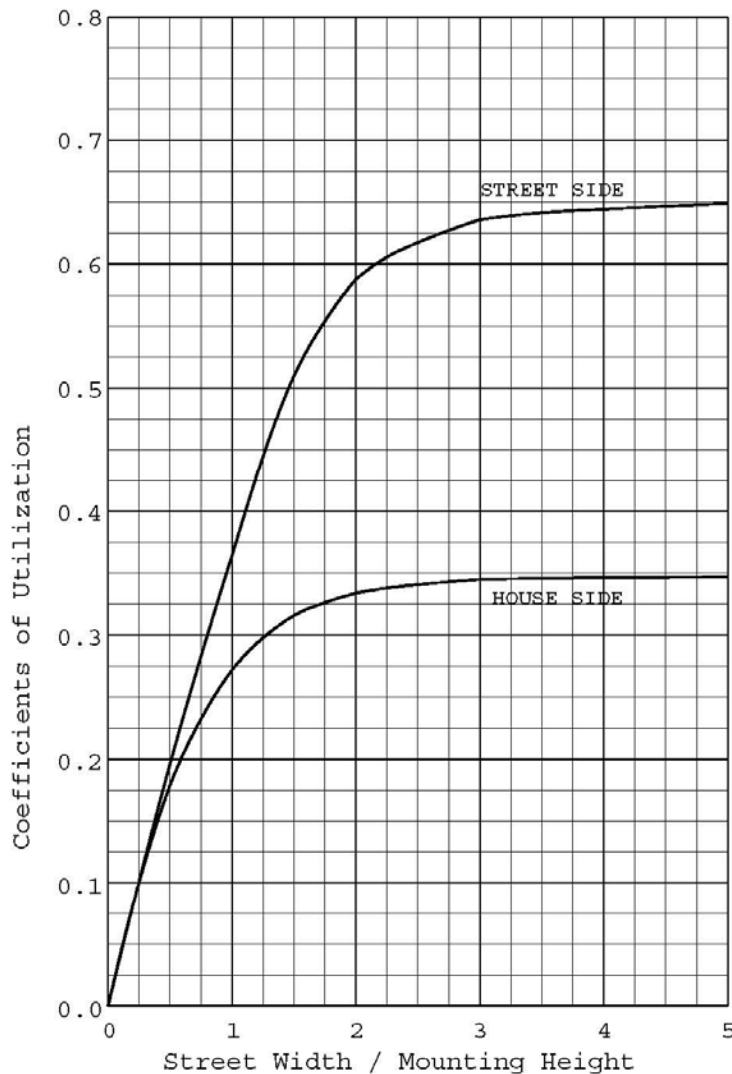
#### COEFFICIENTS OF UTILIZATION AND FLUX DISTRIBUTION
